Manhole Inspection Summary

Manhole # S33QQ_024MH

Location Address: **118 MACE ST**

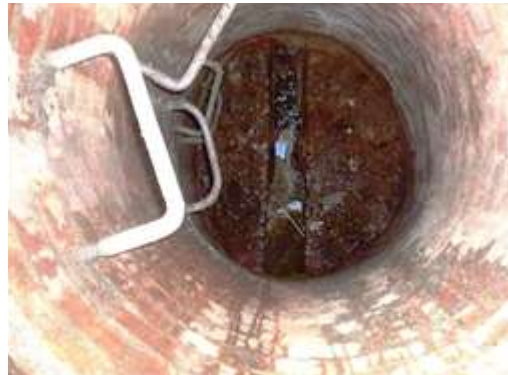
Top View

Evidence of surcharge - Bench debris.
Channel debris.

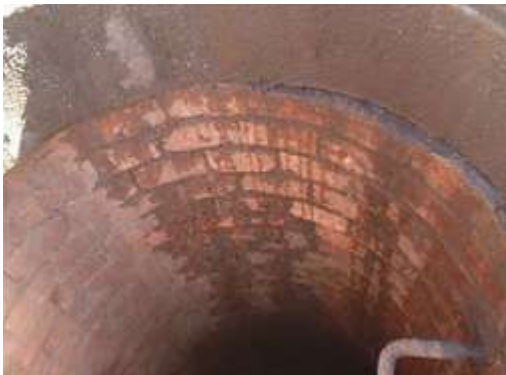
Defect

Frame leaks. Adjustment deterioration
and infiltration - other side.

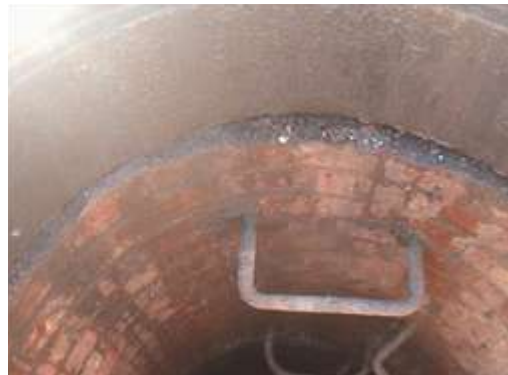
Defect

Frame leaks. Adjustment deterioration
and infiltration.

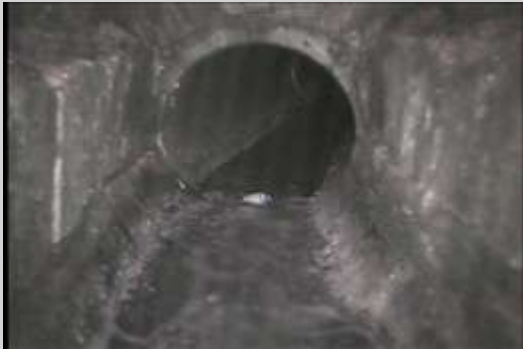
8 in. Circular Gravity Sewer Pipe Out @ 12 O'Clock

Deposits: ☐ None ☒ **Mud** ☐ Sludge ☐ **Debris** ☒ **Grease**

Silt Depth: **0** (in.) Deposits Extent: **Light**

Infiltration: **Evidence** Pipe Seal Cond: **Unknown**

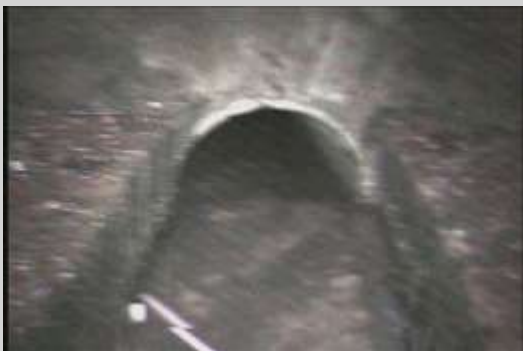
8 in. Circular Gravity Sewer Pipe In @ 6 O'Clock

Deposits: ☐ None ☒ **Mud** ☐ Sludge ☒ **Debris** ☐ Grease

Silt Depth: **2** (in.) Deposits Extent: **Medium**
